MISSISSIPPI RIVER AND TRIBUTARIES SYSTEM

2011 POST-FLOOD REPORT

APPENDIX F
ENVIRONMENTAL AND CULTURAL RESOURCES

ENTRAINMENT OF PALLID STURGEON THROUGH FLOODWAYS DURING THE 2011 LOWER MISSISSIPPI RIVER FLOOD

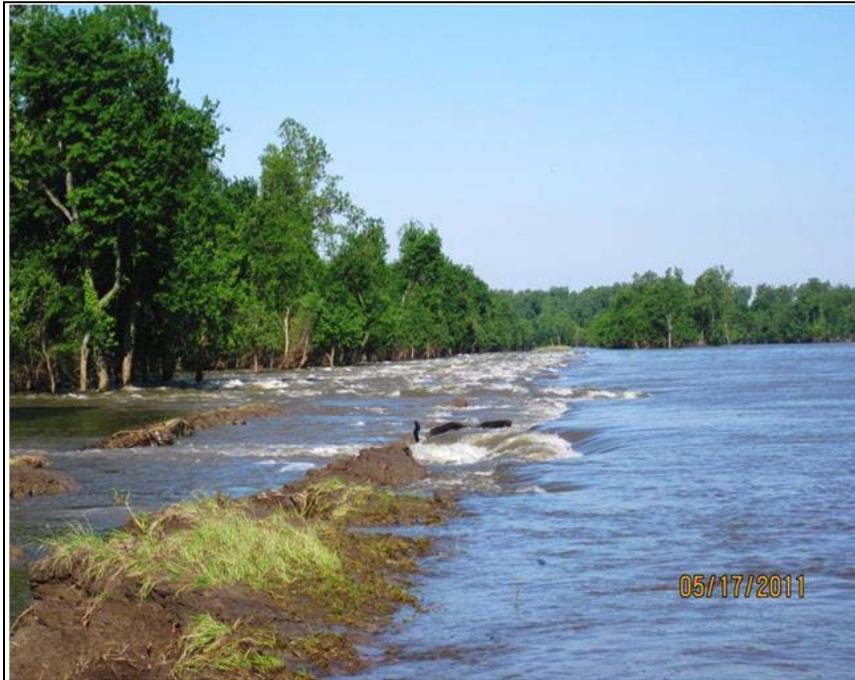
Figure 1-1. Lower crevasse near St John's Bayou and New Madrid, MO.

Lower Crevasse (near New Madrid, MO and St John’s Bayou). A total of 32 individuals were collected at the lower crevasse representing only seven species (Table 1.1). The majority of the fish collected were in hoopnets (Figure 1.4). The dominant species collected was silver carp and accounted for half of our sample. Notable fishes included black buffalo and stonecat. No sturgeon were observed or captured. Low catch on trotlines could be attributed to high water velocities at the lower crevasse. Trotlines had the majority of bait still on the line and were fished in velocities ranging from 1-2 meters/second compared to hoopnets fishing in velocities of 0.5 – 3 meters/second with similar water depths ranging 6-14 feet. Maximum depth detected at sampling sites was 31 feet.

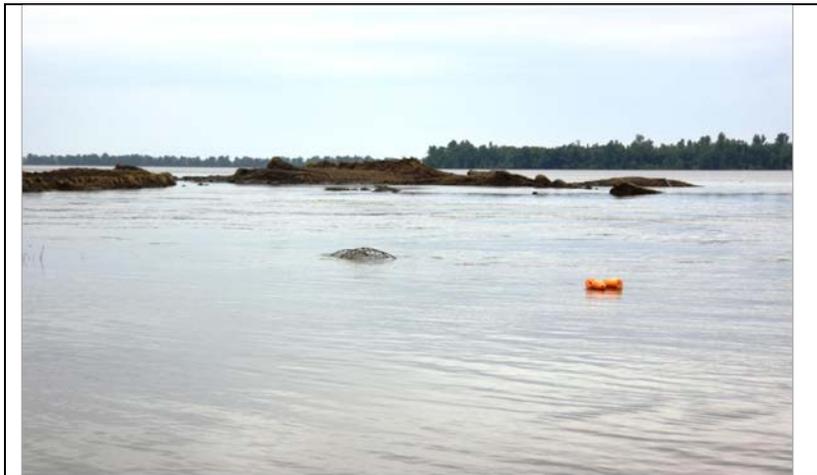
Figure 1-5. A hoopnet set in the vicinity of the upper crevasse at Birds Point illustrating the shallow water and decreasing river levels that left the net exposed during the overnight set.

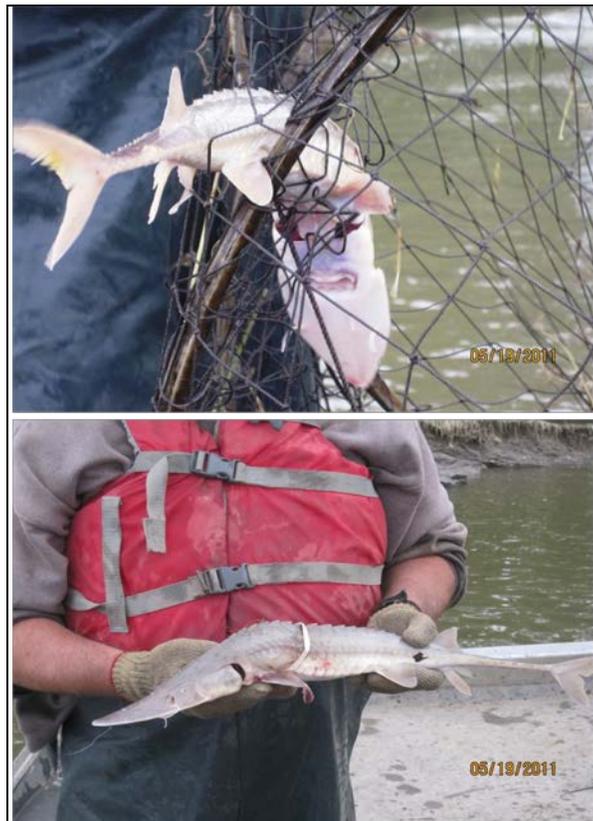
Figure 1-6. A shovelnose sturgeon captured in a hoopnet near the upper crevasse at Birds Point (upper) and the rubber band girdling the mid-section of the body (lower).

Upper Crevasse (at Birds Point). A total of 14 individuals were collected at the upper crevasse representing only four species (Table 1.1). Freshwater drum comprised 64% of the catch. The majority of the fish were collected on trotlines (n=12). Water depth in the vicinity of the gear was much shallower (2.5-6.9 feet) and velocities were much lower (<0.5 meters/second compared to the middle and lower crevasse (Figure 1-5). However, a scour hole did exist below one gap with water depths of 19 ft. Water dropped almost 1 foot overnight and we had difficulty retrieving the gear the next morning due to extreme shallow depths at some locations. Despite the low catch rates for the upper crevasse sets, a single shovelnose sturgeon was captured in the last hoopnet set on the last day of the trip (Figure 1.6). A rubber band was around the mid-section of the body (Figure 1.6), which was

removed before we tagged and released the shovelnose sturgeon back into the Mississippi River. Despite all the effort using different sampling gear (hoopnets, trotlines, gillnets and trawls), this was the only sturgeon collected during this sampling event. Only one shovelnose sturgeon was collected in the upper inflow crevasses at Birds Point (Table 1.1). The fish was later tagged and released back into the Mississippi River.

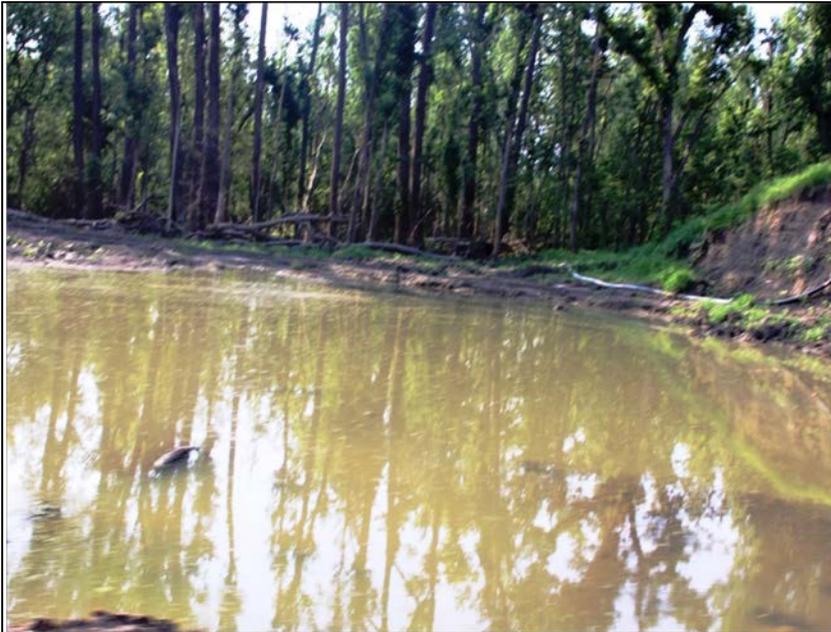
Figure 1.7. A shallow pool of the lower crevasses near New Madrid, MO and St John's Bayou).

The lower crevasses near New Madrid, MO were mainly small, shallow pools, which looked unsuitable for large fish like sturgeon. The small pools appeared to be created by the explosions when opening the lower crevasse. Many of the small pools had dried up, and those pools present were shallow, likely refilled with rain water, and had obvious signs of foraging wading birds (Figure 1.7). No sturgeon were found.

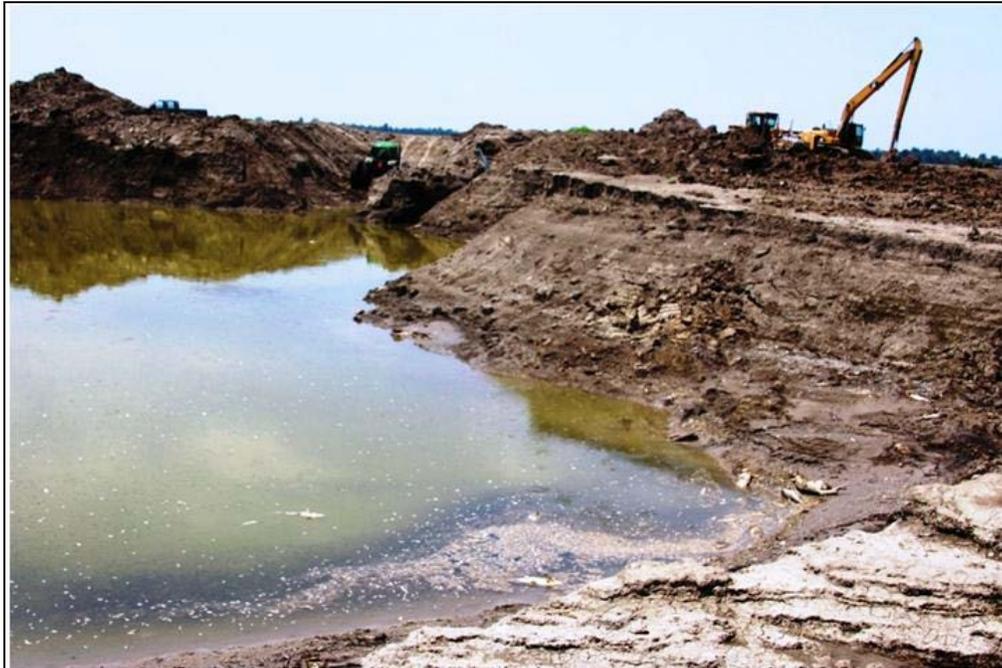
Figure 1.9. Fish kill at the lower blue hole of Birds Point cause by low dissolved oxygen attributing to pumping the water body dry. Notice the steep bank much of the water has already been pump.

In upper crevasse at Birds Point, we surveyed six blue holes on foot. In a blue hole next to the one that produced 20 shovelnose sturgeon in early July (Table 1.2), we picked up one shovelnose sturgeon. In an adjacent blue hole we picked up two more shovelnose sturgeon for a total of three sturgeon (Table 2). We also observed 16 other species of fishes. It was apparent that the blue hole had been pumped likely contributing to the fish kill and refilled with rainwater and underwater seepage.

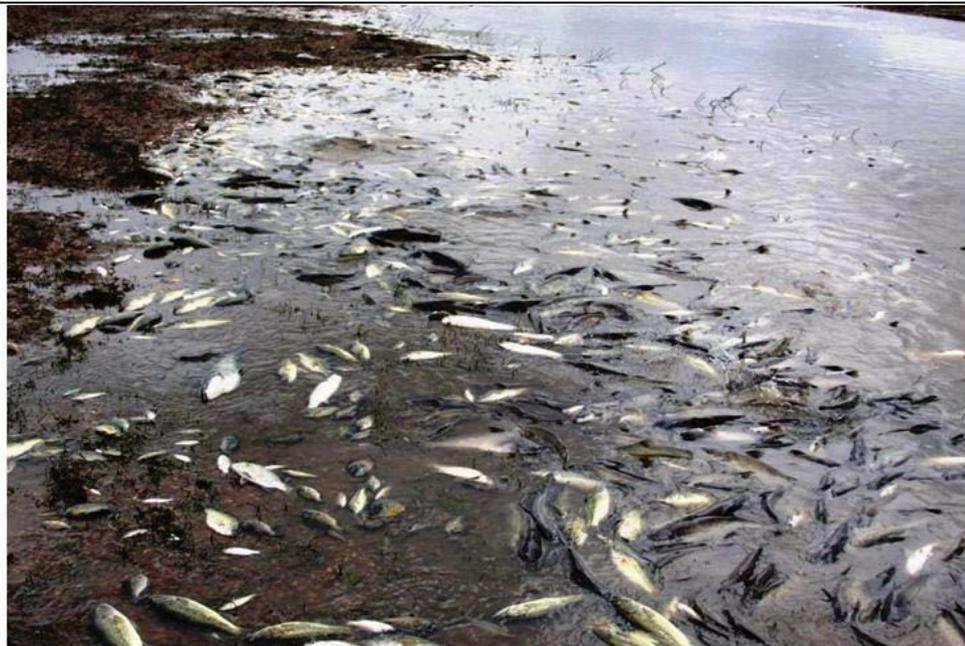
Figure 2.3. Alive and freshly dead fishes on July 14, 2011 downstream of the sluice gates of the Morganza Spillway. Cause of death is low dissolved oxygen. Notice many of the fishes (bass and bluegill) are backwater species and very few river species.

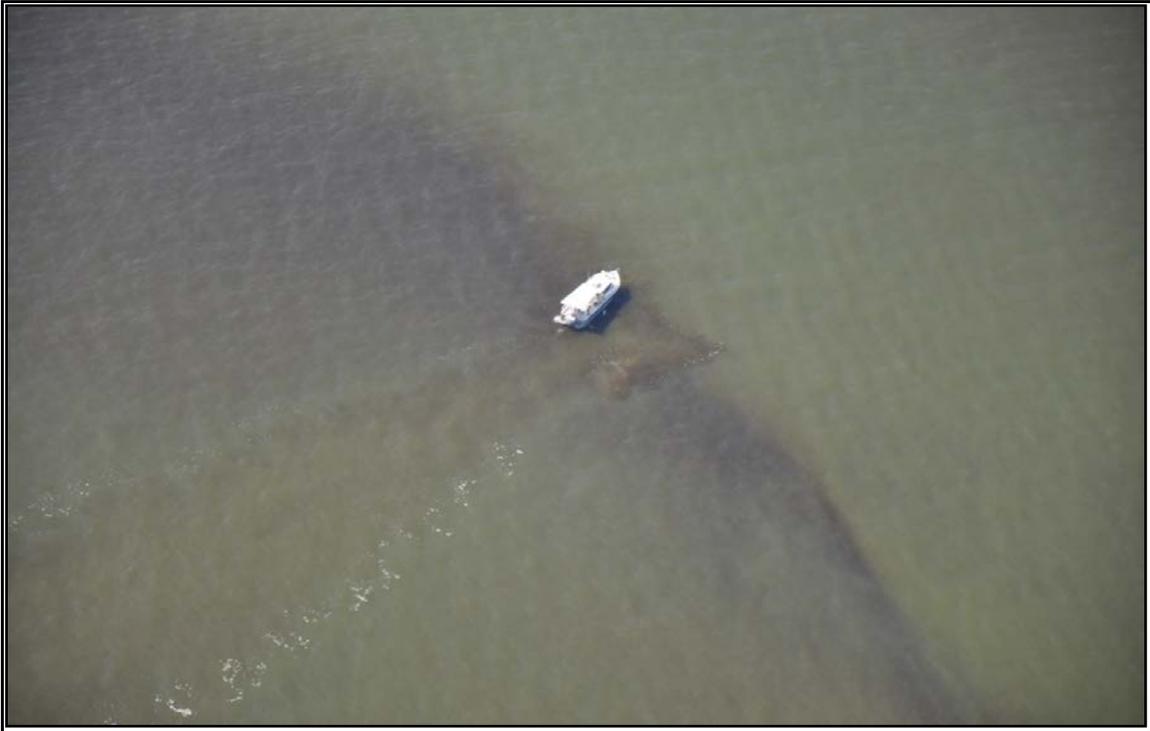
Figure 26. June 27, 2011 Aerial Photo of Algae Bloom and MDMR Boat Collecting Phytoplankton Sample

As the dissolved oxygen and salinity began to return to normal levels, there was an increase in algal blooms in the western Mississippi Sound. On June 27, 2011, a phytoplankton bloom was reported in the western Mississippi Sound. Aerial photographs were taken of this bloom but identification of type was not recorded (Figure 26). On July 27, 2011, a bloom of *Chattonella spp.* was investigated at the Gulfport and Long Beach shorelines. This bloom caused a significant fish kill.

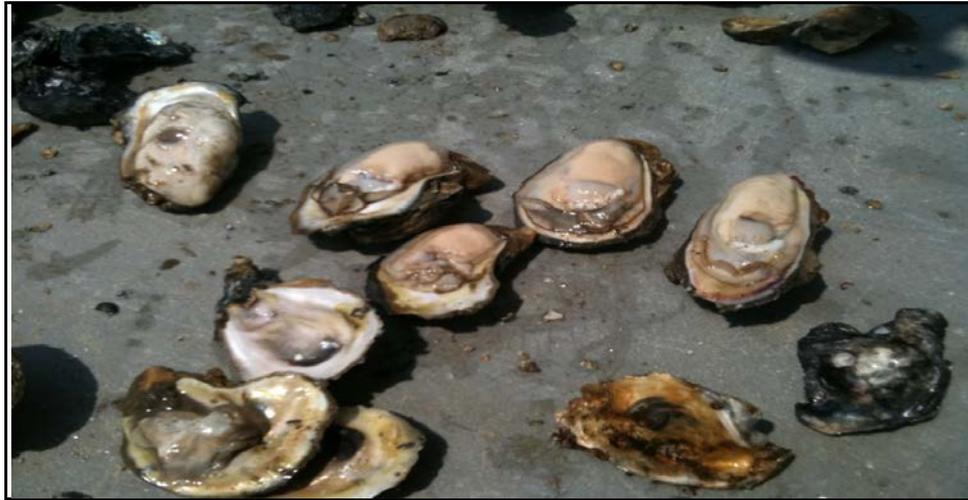
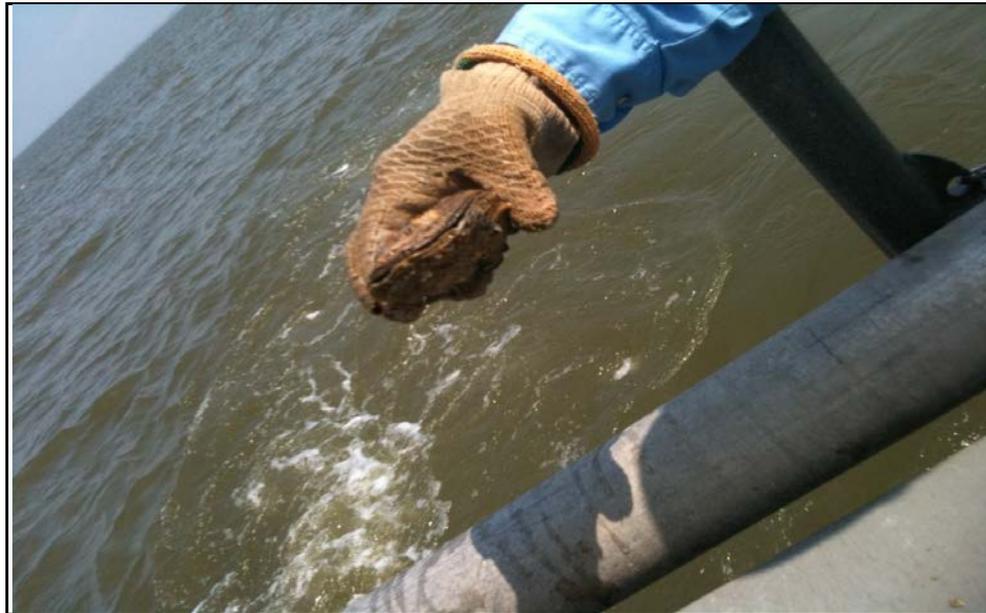
Figure 28. Stressed and Dead Oyster in the Shell

Figure 29. Gaping "Dead" Oyster

Fisheries staff conducted an assessment of the public oyster reefs in Mississippi prior to the opening of the Bonnet Carré Spillway in May 2011. This assessment provided an estimate of 1,945,086 sacks of oysters on the public reefs. In July 2011 a post spillway opening assessment was conducted this estimate resulted in 266,207 sacks of oyster. Mortality as a result of excessive fresh water from the Bonnet Carré Spillway opening and other environmental factor caused a loss of 1,678,878 sacks of oysters. Mississippi's oyster resource had approximately 86% mortality in a two month period. Based on these high mortalities it will require a minimum of three years for a full recovery of the oyster resource, given no additional environmental stressors. Figures 28 and 29 depict the poor condition of oyster during the July reef assessment.
