SECTION IV

MR&T OPERATION AND EMERGENCY ACTIVITIES

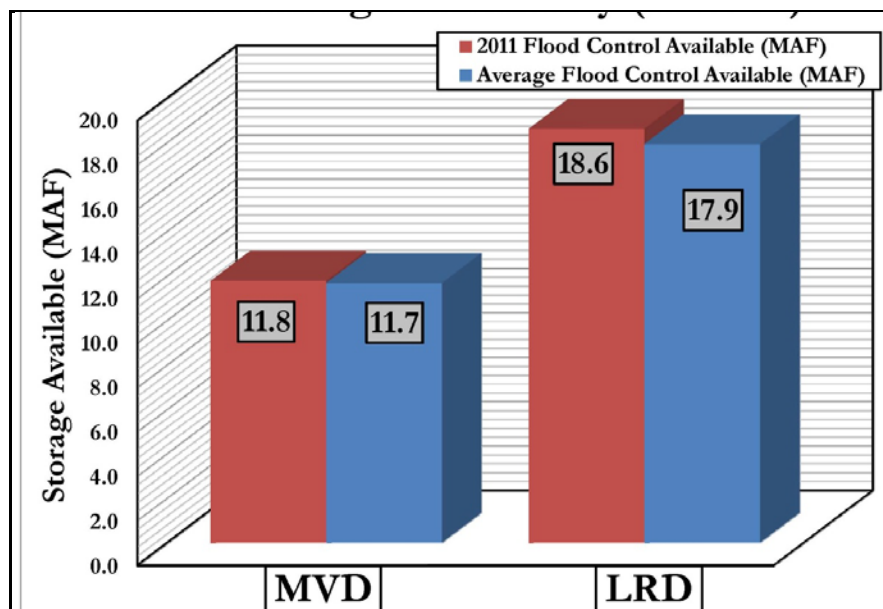
Figure IV-5. Relative Flood Storage Availability – Mid February, 2011 (Million Acre Feet)

Figure IV-5 illustrates the flood storage available within MVD and LRD in mid-February 2011 relative to the average available at that time during other years.

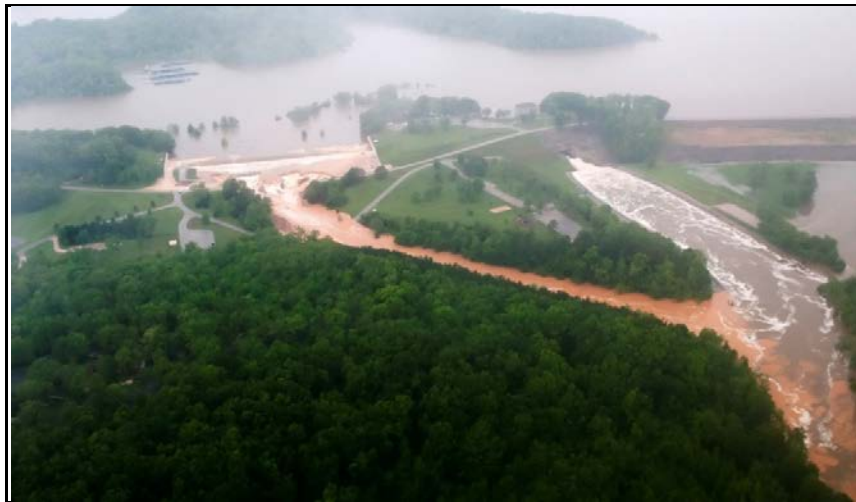
As a result of a second record rainfall, multiple peak inflows of greater than 100,000 cfs raised Wappapello Lake to a record pool level of 400.04 NGVD on May 3, 0.95 ft above the previous record and 5.30 ft above the auxiliary spillway. The berm which had been constructed across the auxiliary spillway was overtopped (photographs IV-1 and IV-2). Spillway overtopping resulted in significant damages downstream. By June 1, the pool level was down to 377.2 ft and 42 percent of the flood control storage utilized. By July 1, the pool level was successfully approaching rule curve level of 359.74 ft.

Photograph IV-2. Post 2011 Overtopping of Spillway

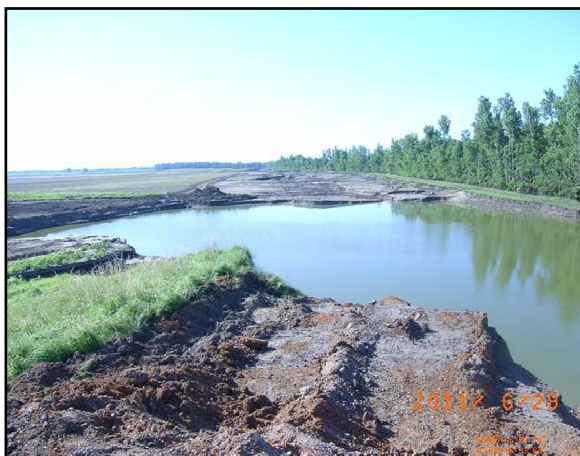
i. Segment #75 and Segment #76 – BPNM Floodway – Make Safe and Stable. Following the operation of the Floodway, the crevassed sections of the levees were no longer functional. The MVD Commander issued a memorandum directing the MVM to implement *make safe and stable* operations based on a target elevation (stage) of 51 feet on the Cairo gage to provide a stable base for flood fight operations and subsequent reset operations by 30 November 2011. Restoration of the crevassed sections for *make safe and stable* was later expanded to include reconstruction of the levee at the upper inflow crevasse to provide FRM to a Cairo gage reading of 55 feet (photographs IV-3 through IV-6).

Photograph IV-3. Upper Inflow Crevasses
Prior to Repairs

ii. The Birds Point New Madrid Floodway. The restore project consisted of rebuilding the System #4016 levees to full height. At the defined *make safe and stable* elevations, the level of protection for the floodway is minimal compared to the pre-operation level of protection. Full reconstruction of the floodway levees requires other elements of the MR&T system, located adjacent to and upstream of the floodway, be remediated to ensure that they can provide full PDF protection.

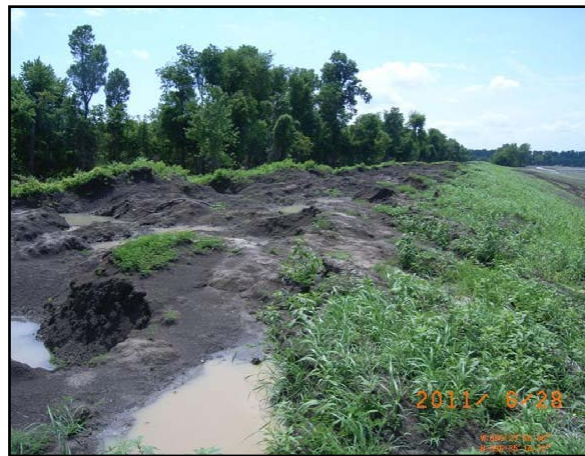
Photograph IV-4. Levee Crown Damaged
Due to Overtopping

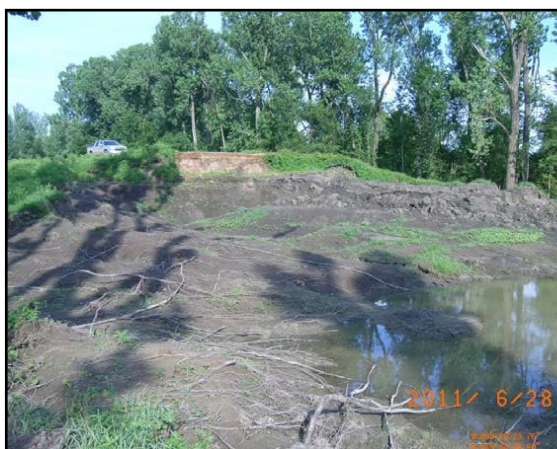
Photograph IV-5. Northern End of the Lower Inflow/Outflow Crevasse Prior to Repairs

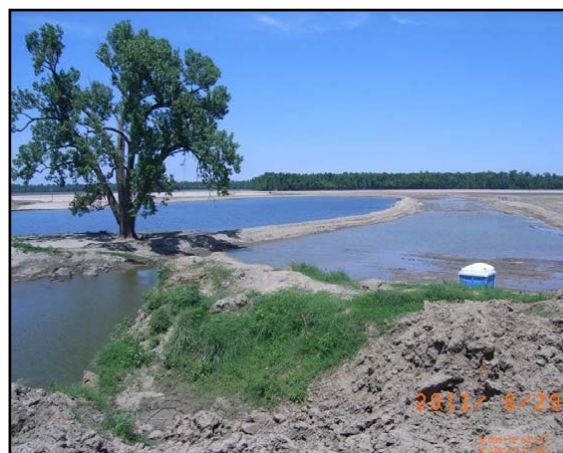
Photograph IV-6. Scour Hole at Center Crevasse Extending into Agricultural Field.

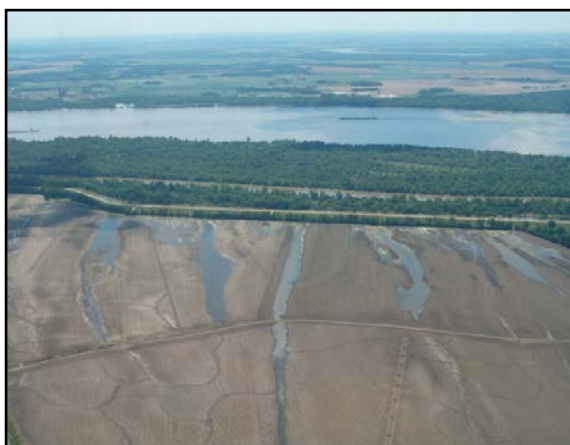
ii. Segment #62 - Leland Chute (AR 2150+00). Moderate seepage (photograph IV-7) exiting at the toe of the levee and beyond as well as numerous small to medium sized boils located in a ditch (photograph IV-8) approximately 100 feet beyond the toe of the levee were identified in an approximately 1-mile long reach.

Photograph IV-7. Aerial View Showing Extent of Seepage

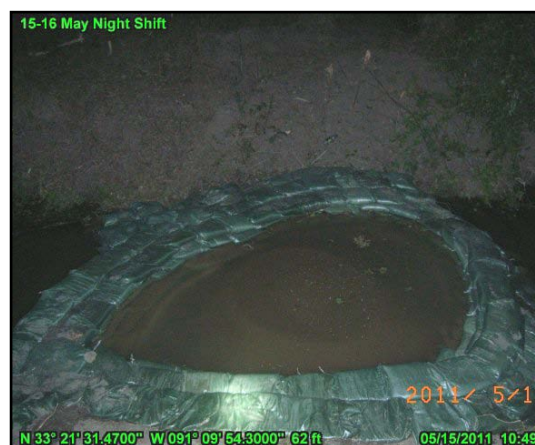
Photograph IV-8. Bagged Sand Boil in Ditch

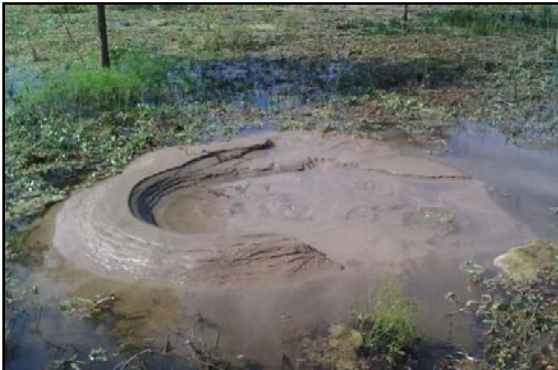
vi. Segment #34 - Tara – (Station 208+00 BEL-327+00 BEL). Moderate to heavy under seepage and numerous active, medium sized sand boils and pin boils were observed within 50 feet of the levee toe between BEL Stations 208+00 and 327+00 near and around Tara Hunting Camp. Two to three large, high energy sand boils with 12- to 16-inch throats were identified between Stations 210 and 220 that flowed 100+ gallons per minute and transported 5+ CY of fine sand/silt before and during remedial action. These boils were located between 10 and 20 feet from the toe of the levee (photographs IV-9 and IV-10).

Photograph IV-9. Sand Cone on Flowing Boil

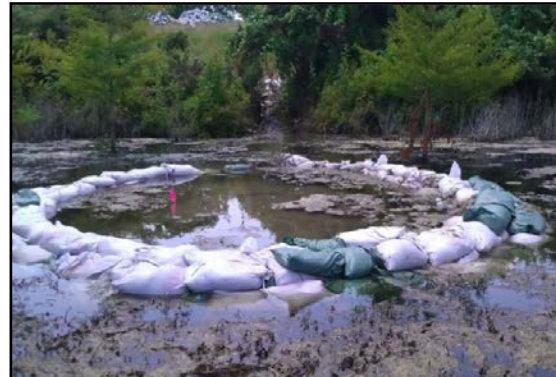
Photograph IV-10. Sandbagged Boils Flowing

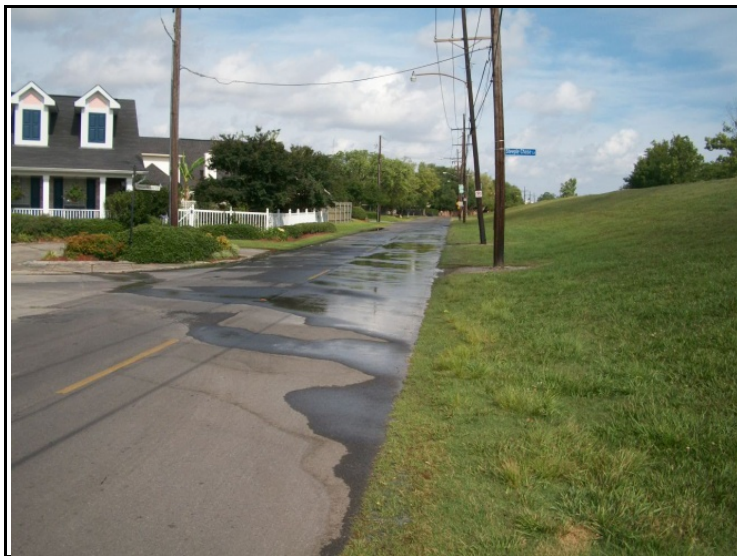
Algiers Seepage. Two sand boils sites were reported within this sector: one at Oak Alley Plantation and one in *Algiers* (photograph IV-11). The Oak Alley sand boil was first reported on 09 May when the Carrollton gage read 16.51 feet. It is located at the intersection of Bessie K Road and River Road. There was no moving material reported and the water flowed clear for the duration of the event. The boil was downgraded to a seepage site on 16 June when the Carrollton gage read 14.62 feet, and the area began to dry on 28 June when the Carrollton gage read 11.48 feet.

Photograph IV-11. Algiers Seepage

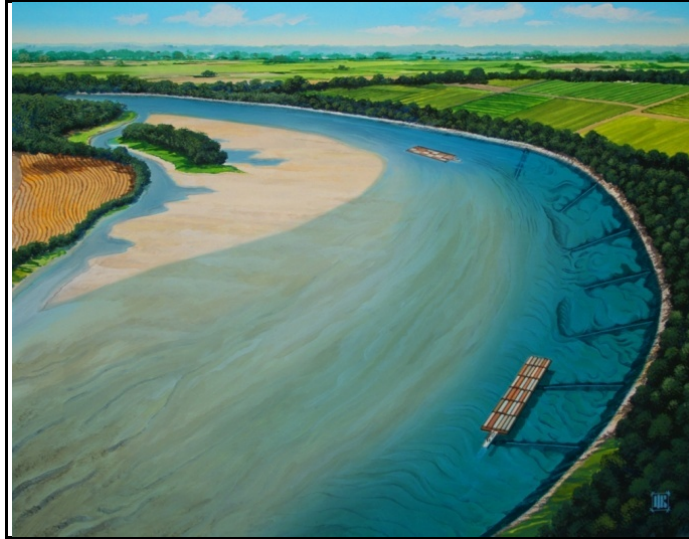
c. Bendway Weirs. Bendway weirs are rock structures constructed in the navigation channel with crest elevations low enough to allow navigation to travel above them. They are angled in the upstream direction from the bank to redirect the flow to provide adequate width for navigation. A schematic example of bendway weirs is shown in figure IV-9.

Figure IV-9. Illustration of Bendway Weirs

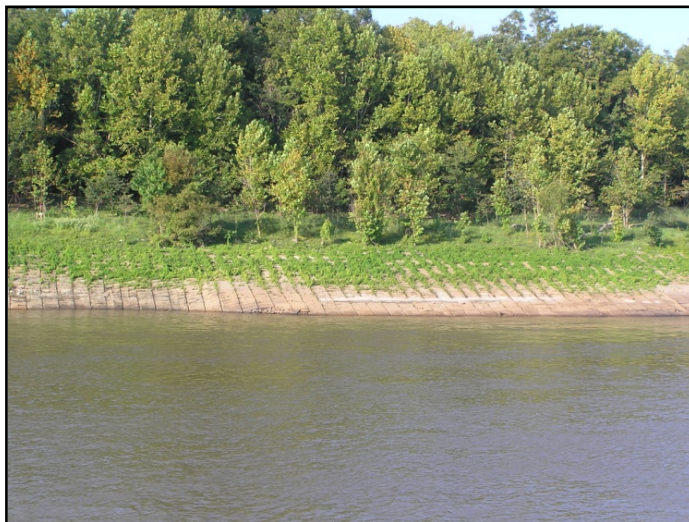
d. Articulated Concrete Mattress Revetment (ACM). An ACM revetment is a flexible structure constructed with connected concrete blocks placed on a sloping river bank. The connected blocks are tied to cables that allow the revetment to conform to minor changes in the bank configuration. Upper bank paving composed of riprap is placed on the bank above the concrete blocks. The revetment provides protection from the erosive forces of the river which maintains the bank in its desired location. Prior to placement of the concrete blocks and riprap, the bank is cleared of vegetation and graded for a stable slope to accept the upper bank paving. A typical revetment that has been in operation for a number of years is shown in photograph IV-16.

Photograph IV-16. Revetment

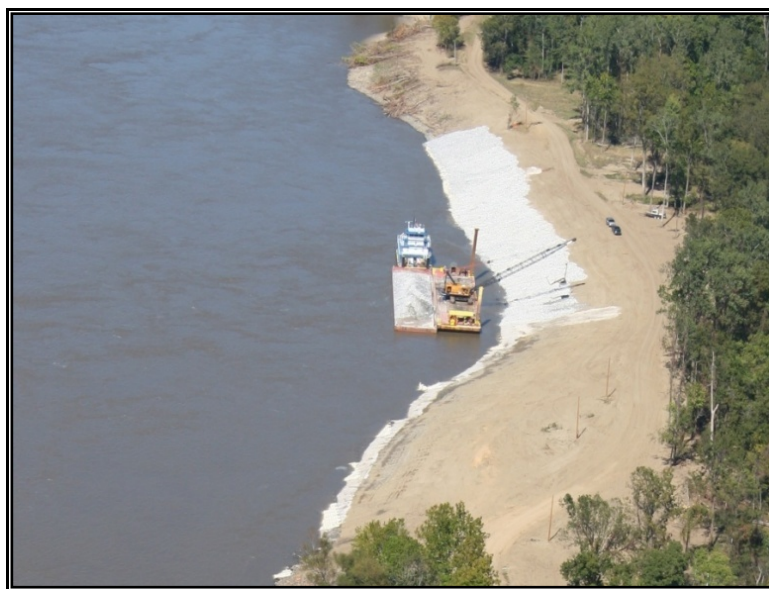
Photograph IV-17 shows an ACM revetment under construction. Note the concrete blocks just above the water surface and the graded bank to accommodate the placement of the upper bank paving.

Photograph IV-17. ACM Revetment Under Construction

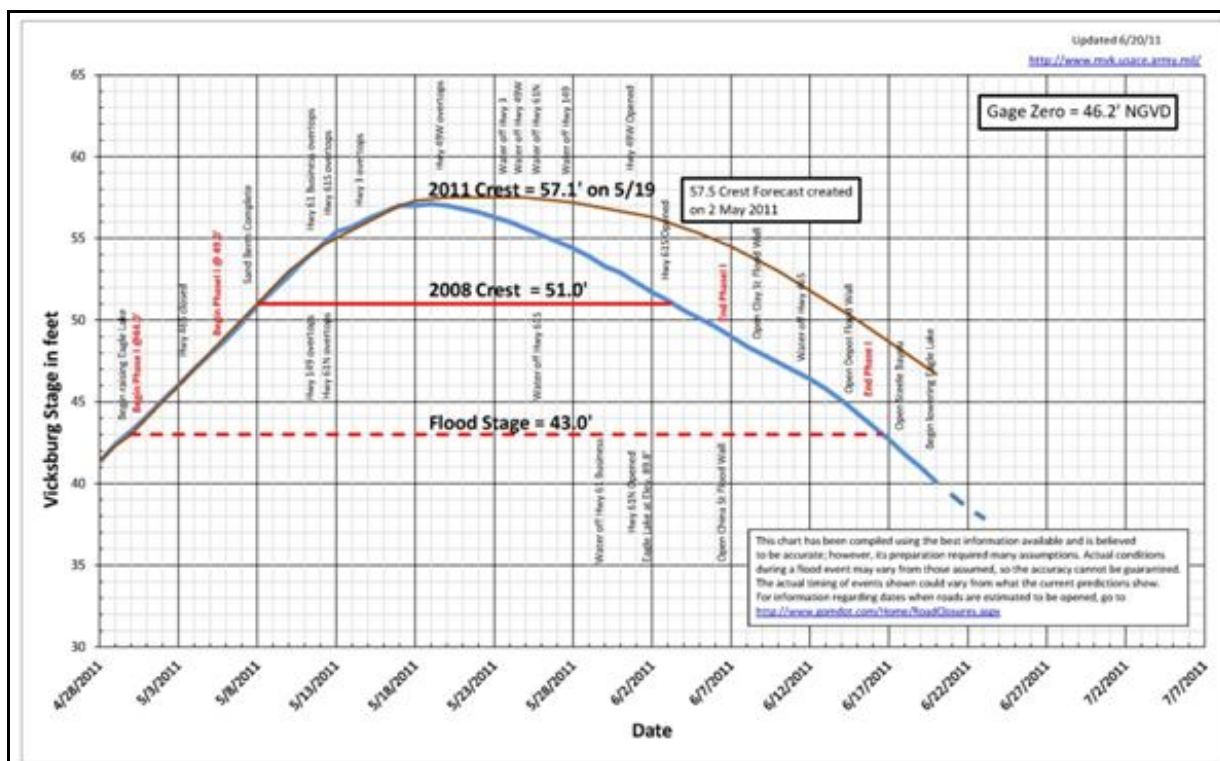
a. Mississippi River. Based on forecasted rainfall, the crest at the Vicksburg gage was originally predicted to be 52.5 feet on May 13. However, on May 2, the forecasted crest was revised to 57.5 feet on May 18 based on a rainfall event of 3 to 8 inches over northern Arkansas, southern Missouri, and southern Illinois. Due to a collaborative effort between the NWS and Corps, the crest forecasted on May 2 was less than a half foot different than the crest that actually occurred on May 18 (figure IV-14). This is a success story for the flood fighters, decision makers, and others who use these forecasts. There were similar crest revisions along the Mississippi River at all gages inside the Vicksburg District boundaries. The crests at Arkansas City and Natchez gages were both revised upwards by 5 feet, and the crest at Greenville gage was revised upwards by 4.5 feet.

Figure IV-14. 2011 Flood Forecasting Crest for the Mississippi River at Vicksburg
The blue line is the 2011 actual stage; the brown line is the forecasted stage.
