ROOM FOR THE R I V E R

Summary Report of the 2011 Mississippi River Flood and
Successful Operation of the Mississippi River & Tributaries System

MISSISSIPPI RIVER COMMISSION

December 21, 2012

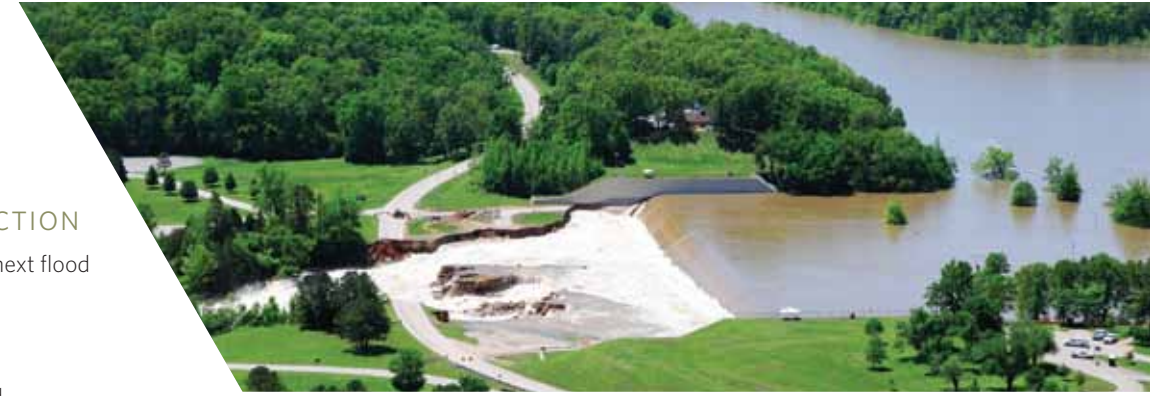
FROM TOP: The flood over-tops the Wappapello Reservoir Spillway, damaging a county highway and the spillway itself. Maj. Gen. Michael Walsh (right) and Maj. Gen. John Peabody (left) inspect flood damages. This publication is a summary of the comprehensive 2011 Post-Flood Report.

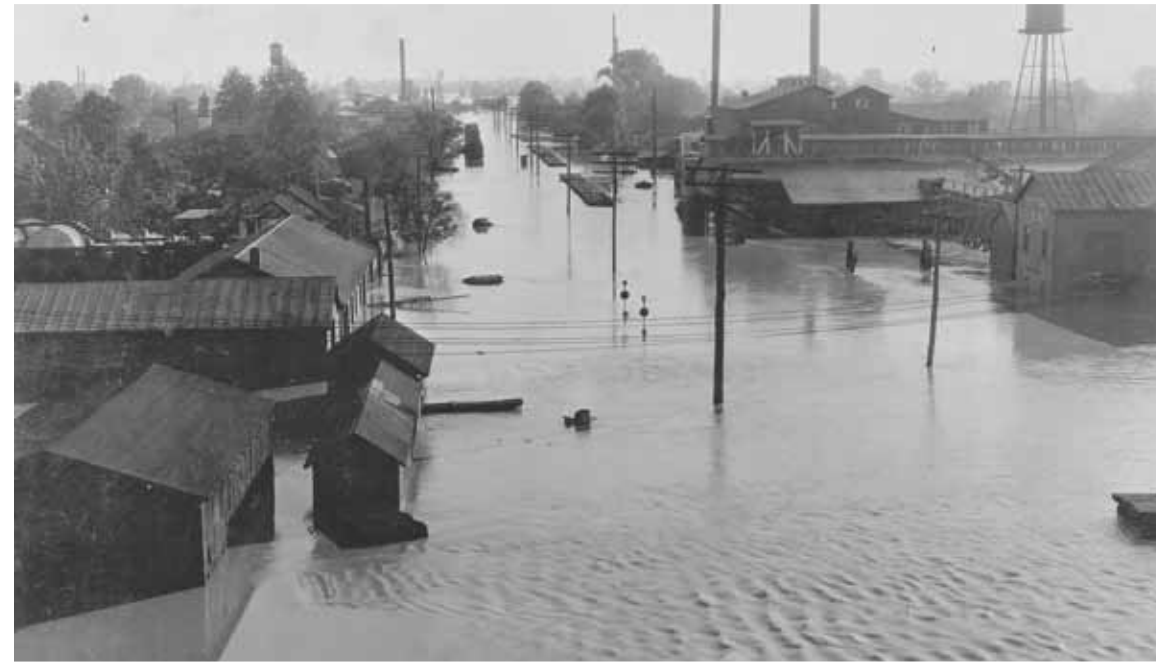
The lower river is basically a funnel for the world's third largest drainage basin—exceeded in size by only the Amazon and the Congo.

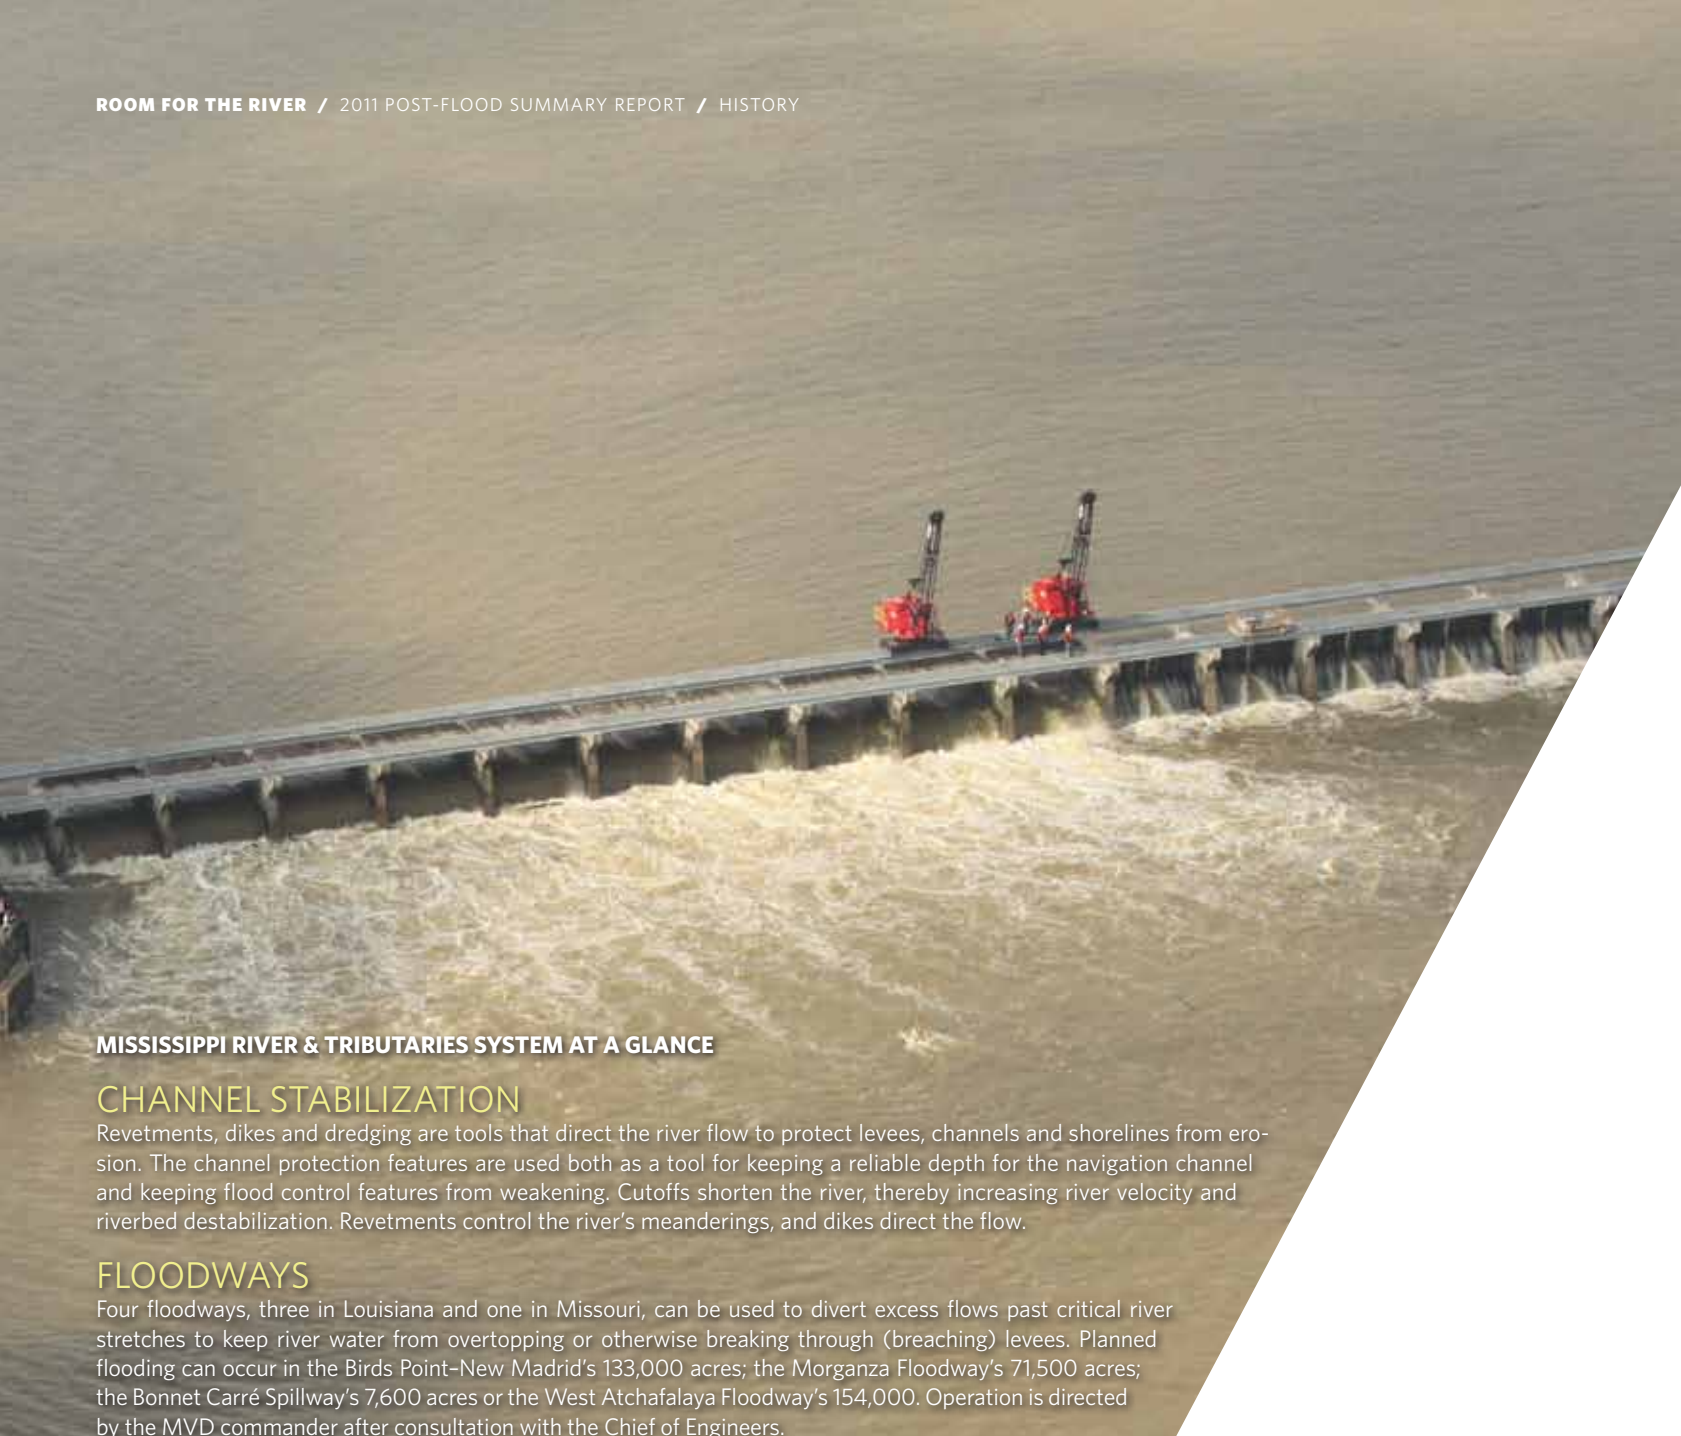
MISSISSIPPI RIVER & TRIBUTARIES SYSTEM AT A GLANCE

Project levees, constructed of compacted clay and rivaling in length the Great Wall of China, are designed to contain swelling floodwaters. Levees form the backbone of the MR&T System. Some 3,727 miles of levees have been authorized through the project, 3,486 miles of those completed, providing protection from Cape Girardeau, Mo. to Venice, La. Levees, constructed by the Federal Government with routine maintenance performed by local interests, protect the fertile lands of the river valley from recurrent annual flooding, except where it enters the natural backwater areas or is purposely diverted.

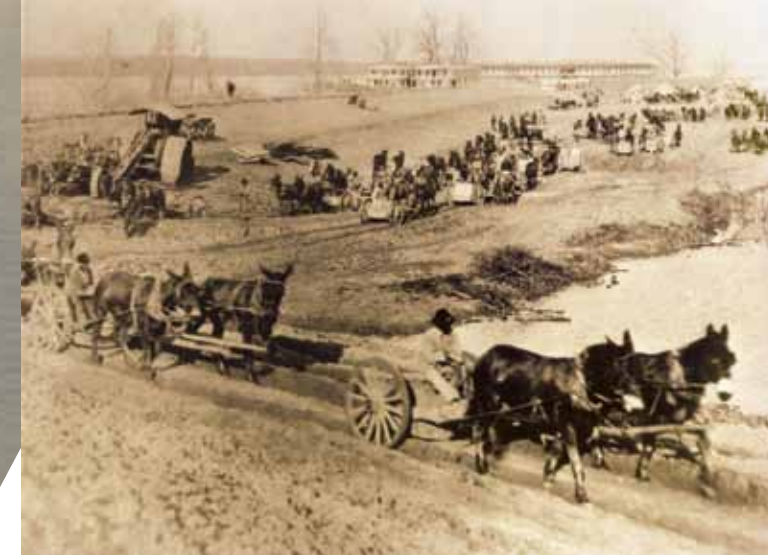
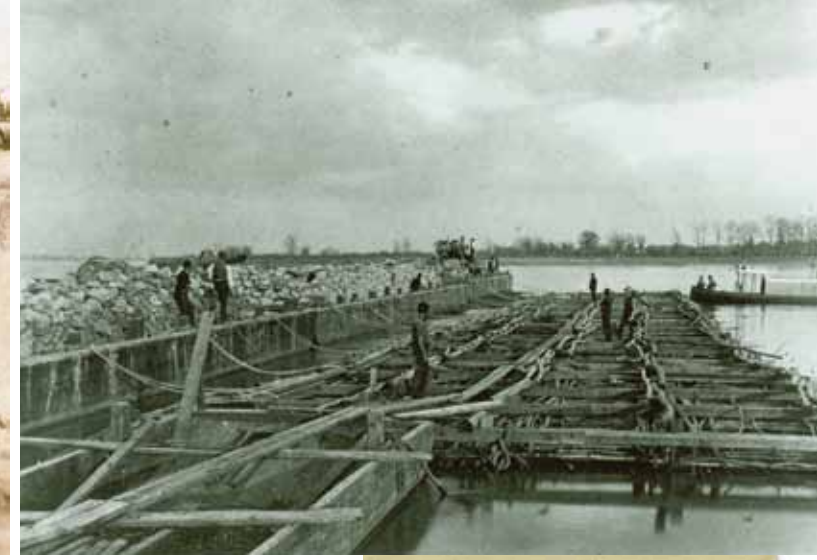
ABOVE, FROM LEFT: Early levee construction, around 1910. Workers construct a willow mat that will be loaded with rock for channel protection or wing dike formation.

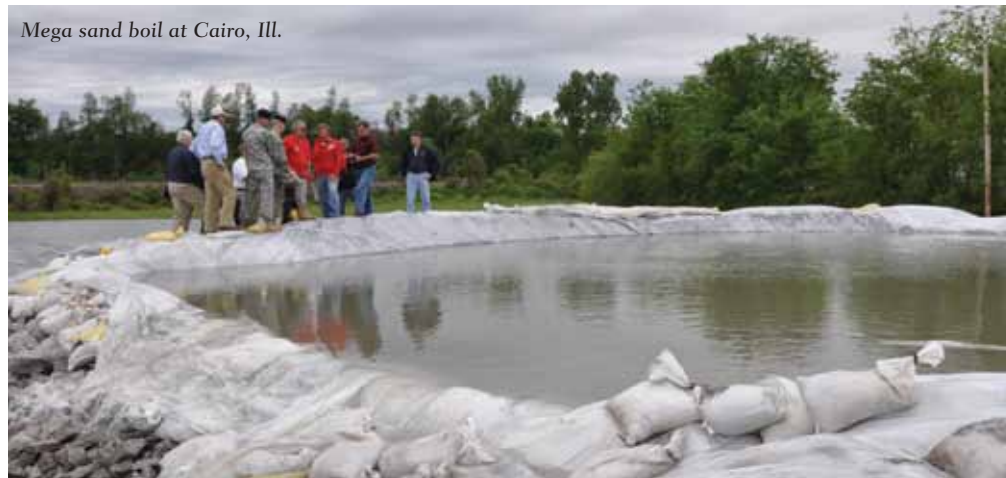
Mega sand boil at Cairo, Ill.

Although no improved MR&T dams or levees have ever failed, small boils of water began showing up on the land side of levees across the region. The boils, caused by the immense pressure exerted by the river, were a major concern. When river levels rise, the additional weight of the water creates pressure that tries to find an escape route through the foundation of the levee system. Water essentially finds conduits under the levees and boils up through the ground on the land side of the levee.

The boils can carry sand, clay and other foundation materials from beneath a levee, weakening the structure's foundation. Left unchecked, a sand boil can increase in flow and undermine the protective levee, causing it to fall, often with catastrophic consequences.

Crews fought thousands of sand boils along the river, using sandbags, plastic and rock to build circular rings around the boils as a barrier. Encircling the sand boils halted the movement of sand and soil, thereby reducing the risk of the boils causing levee failure. The strategy worked; not one mainline MR&T levee along the Mississippi failed.

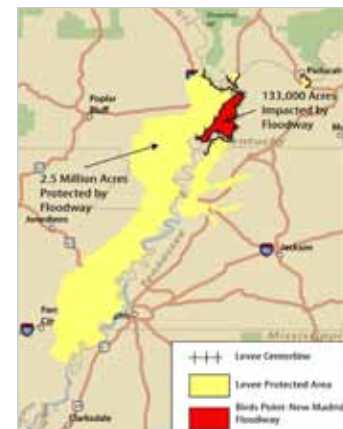
BIRDS POINT-NEW MADRID FLOODWAY at a glance

- Completed in 1933
- Operated in 1937 and 2011
- 3–10 miles wide; 36 miles long
- 133,000-acre floodway, when activated, provides protection to 2.5 million acres
- Diverts 550,000 cfs
- Activated by removing fuseplug levee sections with explosives
- Alternate methods of operation were evaluated to improve performance

While the other floodways are designed to be opened in a slow, sequential manner, Birds Point—due to its infrequent usage—is designed with earthen fuseplugs instead of gates. Originally designed to degrade naturally by the river’s forces at a certain flood stage, the floodway is now activated by detonating explosives within fuseplug wells and lateral pipes installed in the 1980s at three sections of the frontline levee. The floodway creates a 30-mile bypass which diverts up to 550,000 cfs from the river, inundating about 130,000 acres for which the Corps had secured permanent flowage easements from landowners.

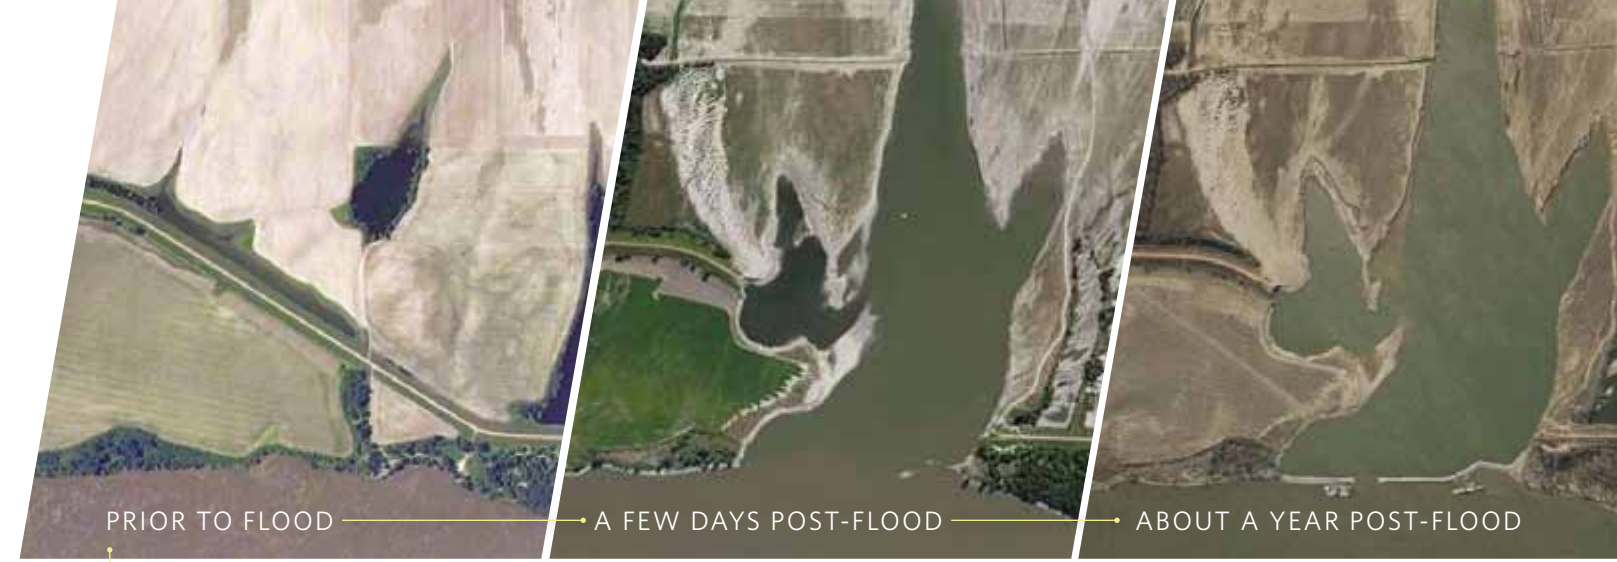
PRIOR TO FLOOD — A FEW DAYS POST-FLOOD — ABOUT A YEAR POST-FLOOD

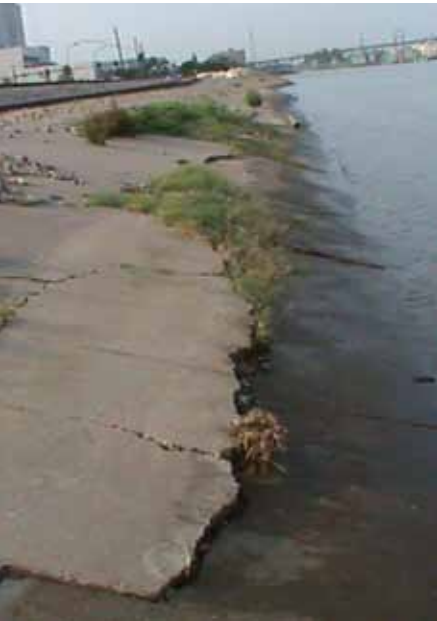
FAR LEFT: Post-flood cracking of the concrete at the Baton Rouge waterfront. LEFT: The same shot after stabilization with rock.
